[BULLETIN] AX4N Water Damaged PCM

1999 - 2003 FORD Windstar equipped with AX4N transmission
2004 - 2007 FORD Freestar equipped with AX4N transmission
2004 - 2007 Mercury Monterey equipped with AX4N transmission

FORD TSB 6-14-10, issued July 24, 2006 (supersedes FORD TSB 5-23-7 issued November 28, 2005)

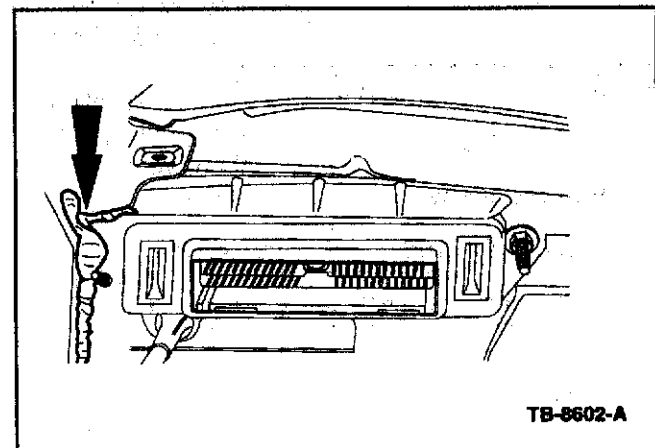
Figure 2 - Article 06-14-10

Inspect the body sealant on the bulkhead to ensure it is not protruding out causing the cover not to seal properly in that area. (Figure 2) If sealant is interfering with the PCM cover, remove excess with a sharp tool. Reinstall the PCM cover ensuring the cover seals and is flush with the bulkhead.
